HISTORIC PRESERVATION CERTIFICATION APPLICATION
REQUEST FOR CERTIFICATION OF COMPLETED WORK

1. Name of property: Burgess Carriage House (Burgess Estate Complex)
Address of property: Street 8450 Main Street (Frederick Road)
City Ellicott City County Howard State Md Zip 21043
Is property a certified historic structure? ☒ yes ☐ no If yes, date of certification by NPS: 4/29/88
or date of listing in the National Register: _____

Burgess Carriage House

Historic Pres. Certification Applic.
8450 Main Street, Ellicott City, MD
North and East Elevations--
Before/After

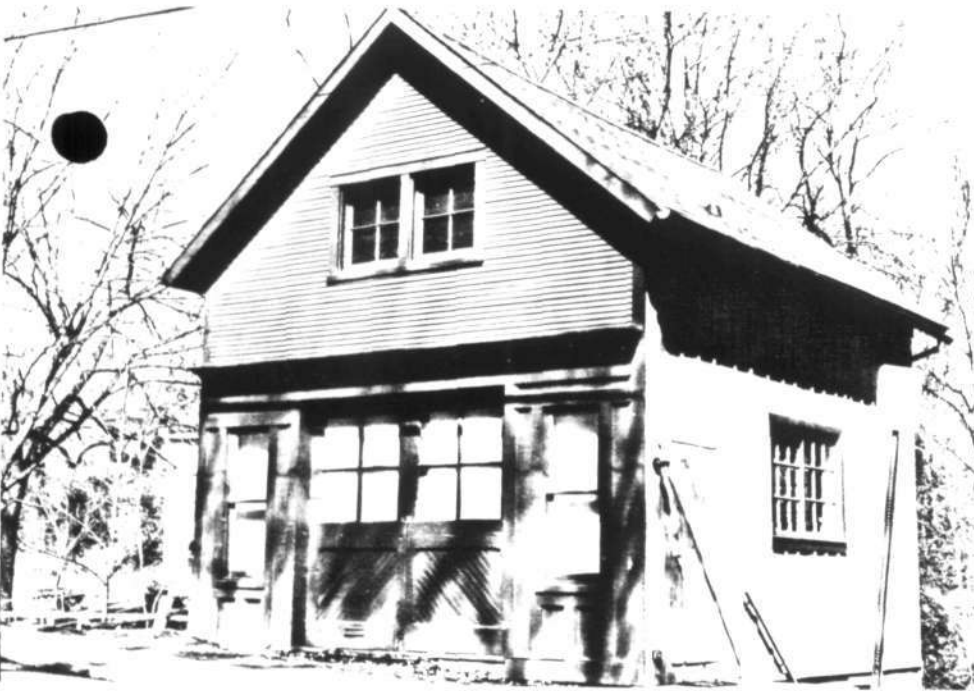
Fig. C-1 Front facade restored using all existing material. Windows and carriage doors repaired. Right side elevation shows new sliding wooden sash with true divided lights to match original plus new "concealed" door used as main entrance. All siding existed pre-rehab.

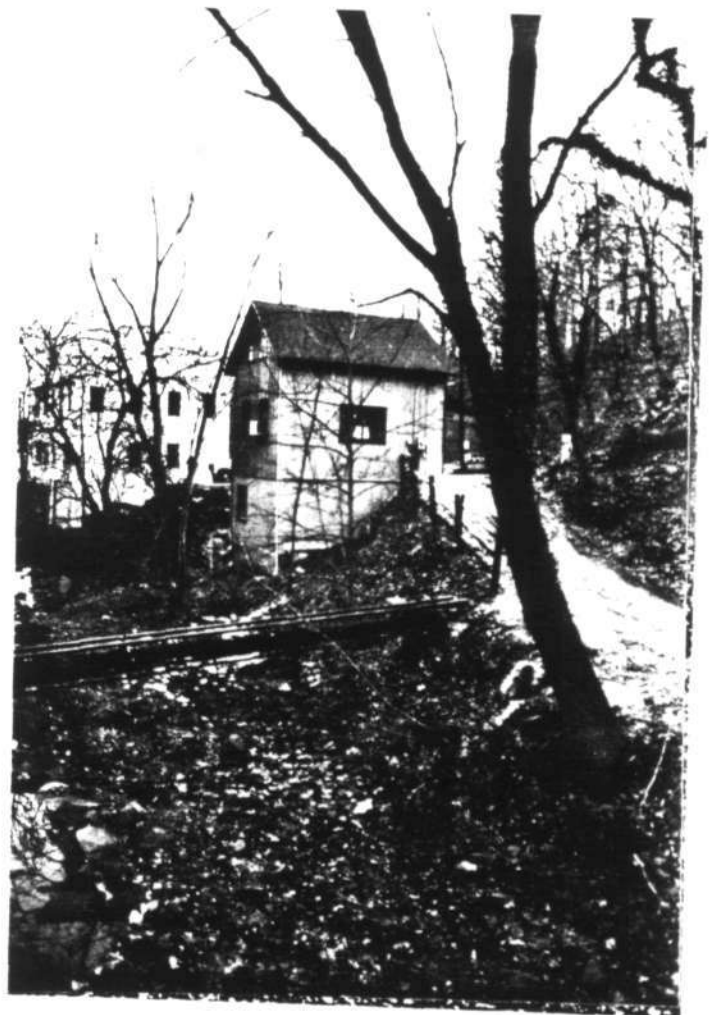
Fig. C-2 Left and rear side elevations after rehabilitation. Left elevation has replicated sliding wooden sash to match what existed originally. On rear, new window installed at basement level; heat pump shown in first floor window; and single window in attic converted to pair unit

All siding existed pre-rehab. No other changes to rear or left side elevation. Driveway upgraded slightly; otherwise no site change (new gravel at entrance and a little widening).

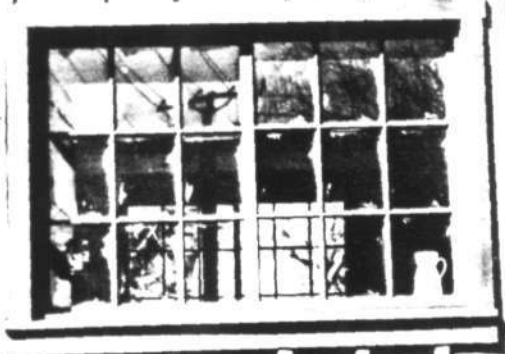
Fig. C-3 Replicated sliding wooden sash installed in original openings on side elevations. Windows are single glazed with true divided lights

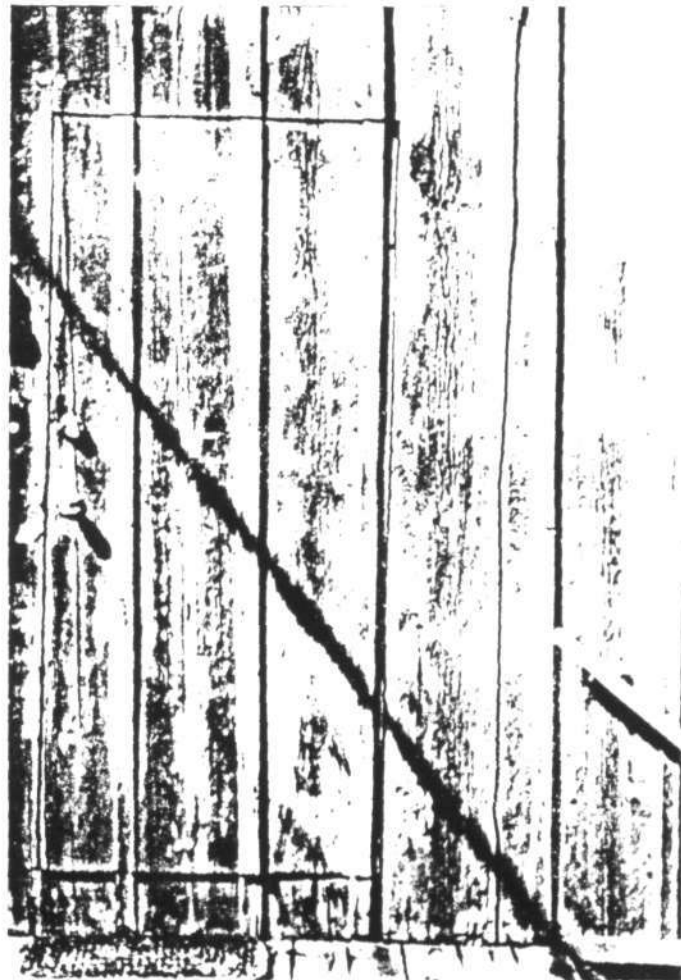
Fig. C-4 "New "concealed" door installed on right side elevation. Existed board and batten used as outside covering.

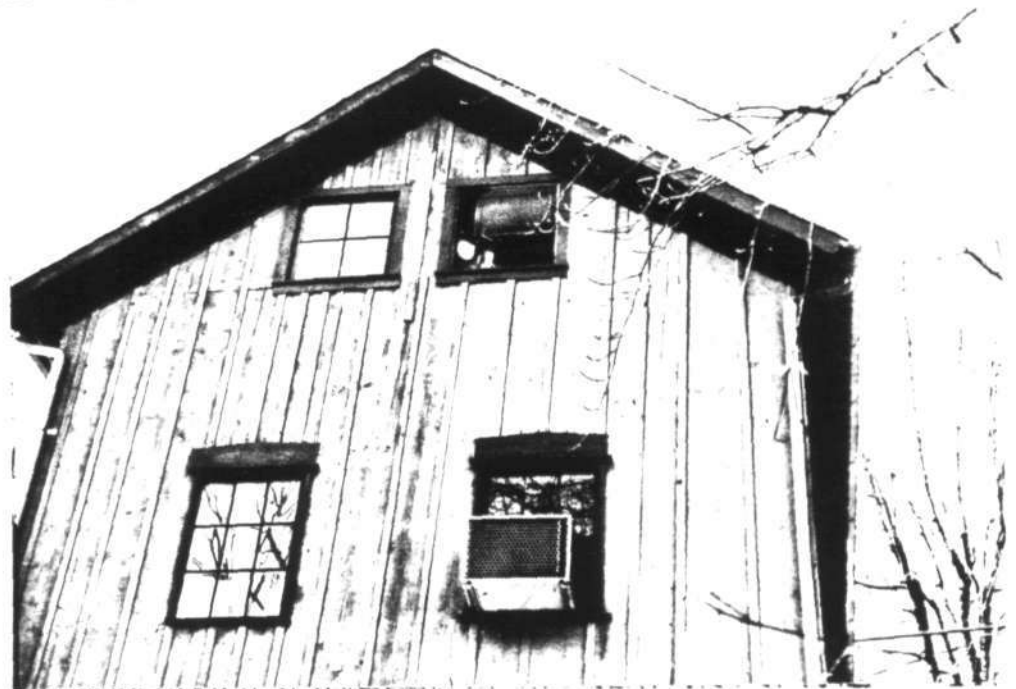
Fig. C-6 Rear elevation after rehab. Windows on first floor retained; board and batten retained. Window in attic converted from single 4-light opening to a split paired unit. Heat pump window units placed in 2 right windows to avoid cuts thru wall.
